Conway Park

Environmental Conditions Update Meeting
December 5, 2018

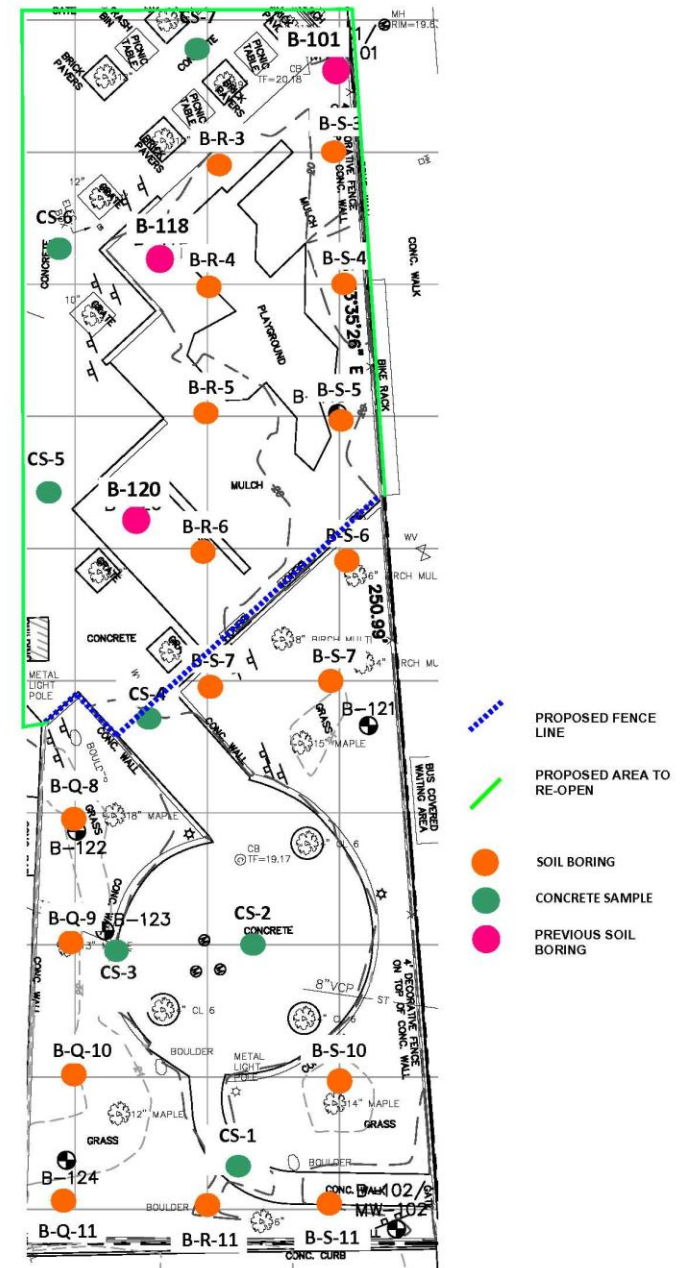
- Northwest portion
 - PCB Concentrations non detect or below 1 ppm
 - Lead - 1 sample met standard, rest below.

- Recommended Reopening the Northwest portion
- Keep Southeast Portion closed for now

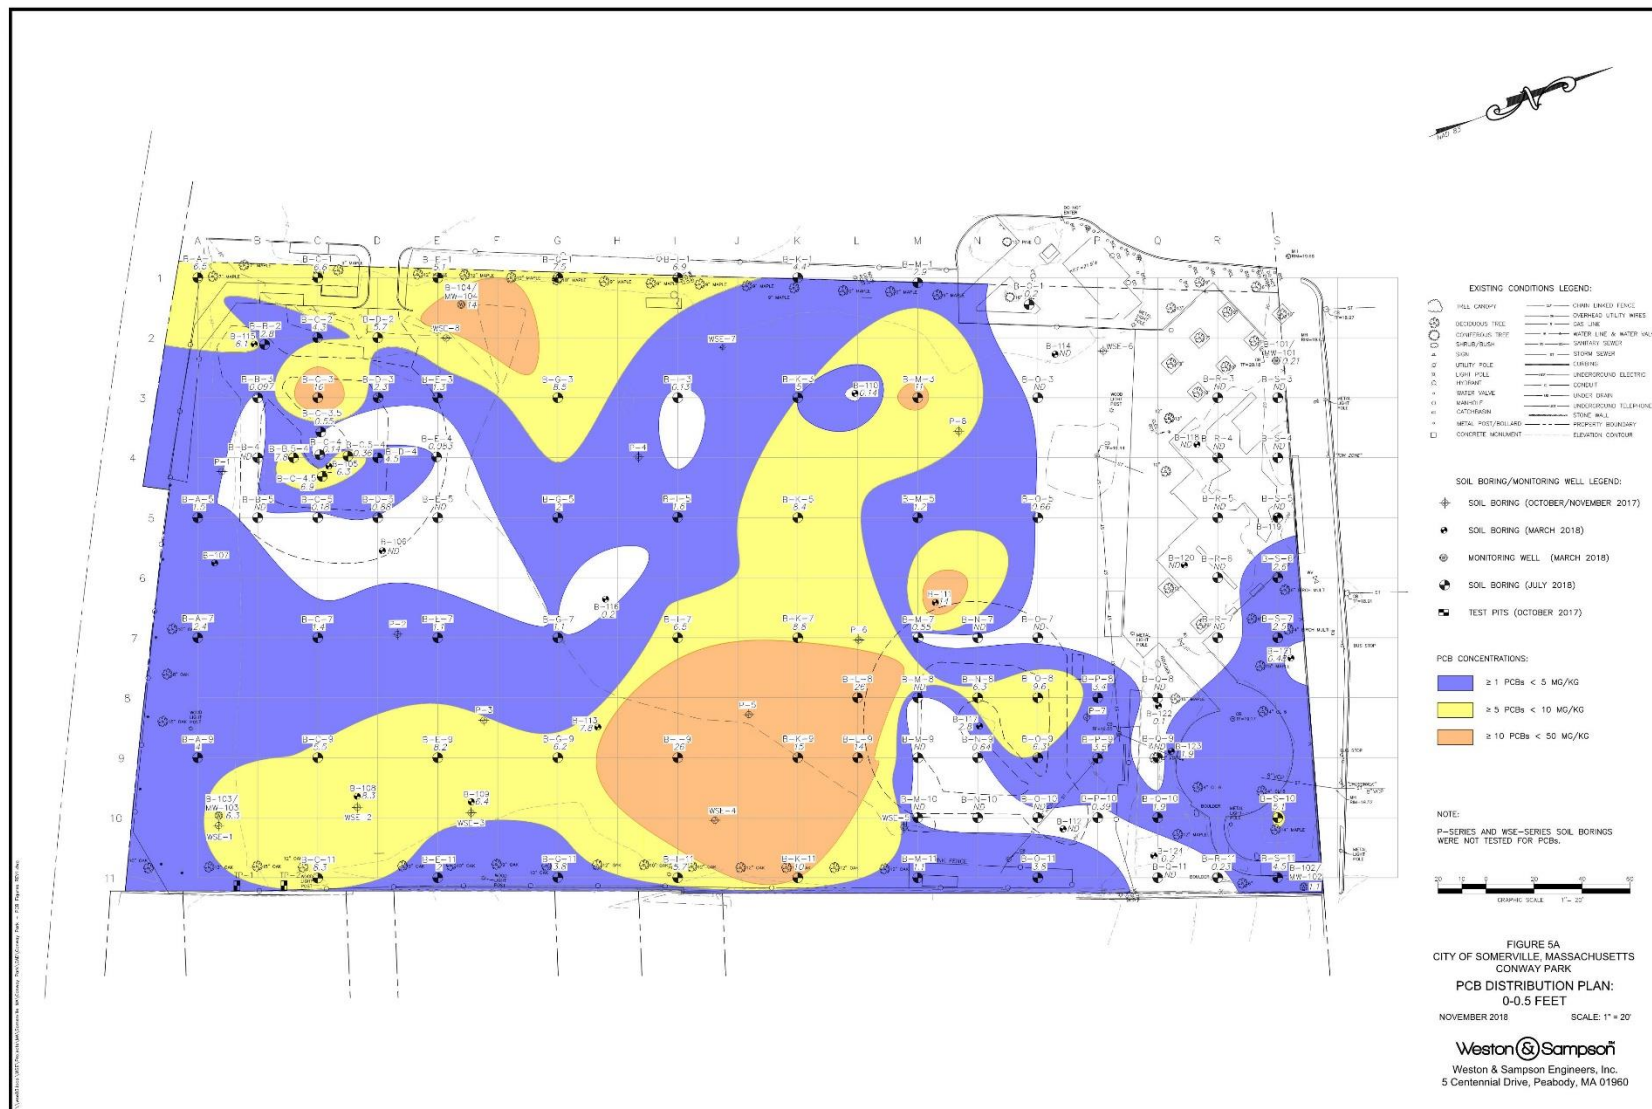
0 – 0.5 feet below grade

- PCB concentrations decrease with depth
- 0-0.5 feet (surficial soil) not as impacted
- Highest concentrations > 7.5 feet below grade
